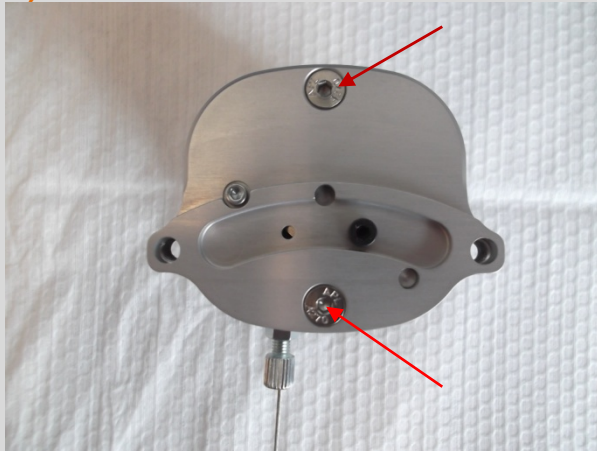
1.)

Move into 1<sup>st</sup> gear

Loosen countersunk head screws and carefully remove casing lid.

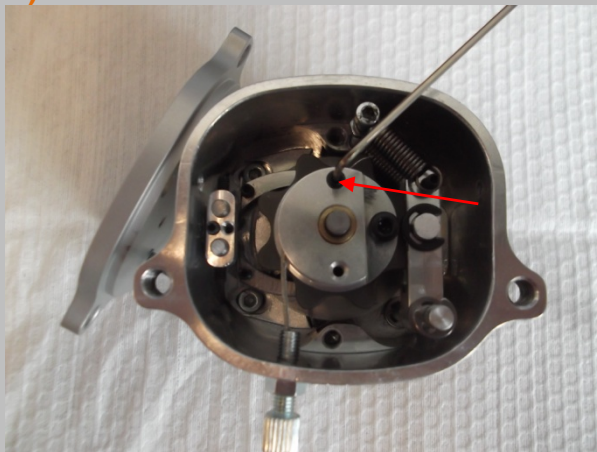
2.)

Loosen the cable retaining screw and remove the defective cable.

Search casing for broken pieces of cable and also remove these.

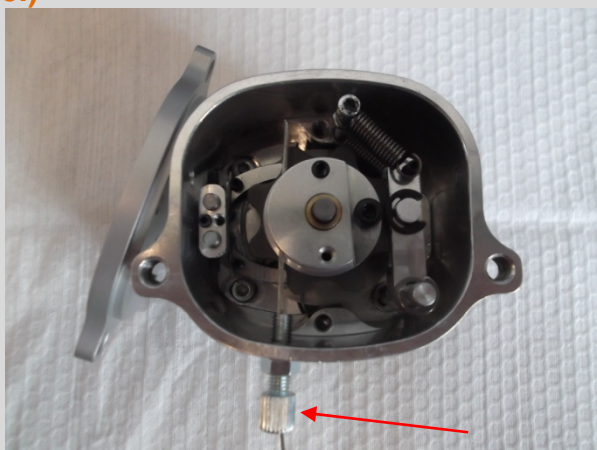
3.)

Thread in new cable.

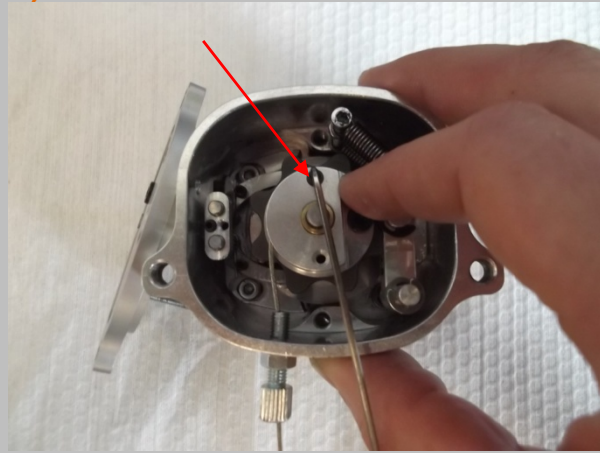
4.)

Use a finger to insert the cable along contour and tighten clamp screw.

The cable must rest tightly on the circumferential groove.

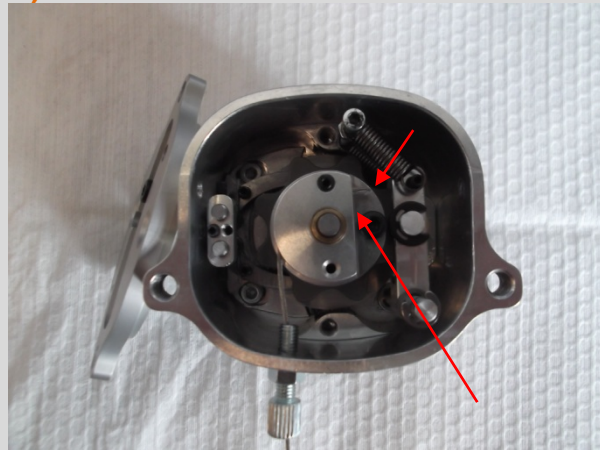
5.)

The end of the cable must protrude around 2-4 mm beyond the marked edge.

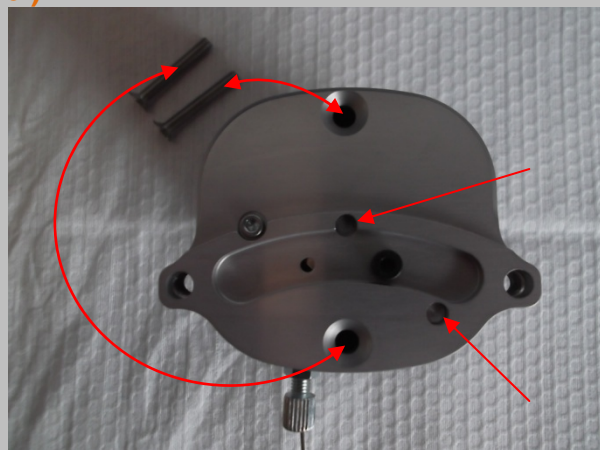
6.)

Carefully replace casing lid.

Ensure that both bolts are cleanly inserted into the lid.

The casing lid must close without gaps.

Tighten the countersunk head screws evenly.
